SPRING BROOK INTAKE DAM

NDI ID NO. PA-00450  
DER ID NO. 35-40

PHASE I INSPECTION REPORT  
NATIONAL DAM INSPECTION PROGRAM

APRIL 1980

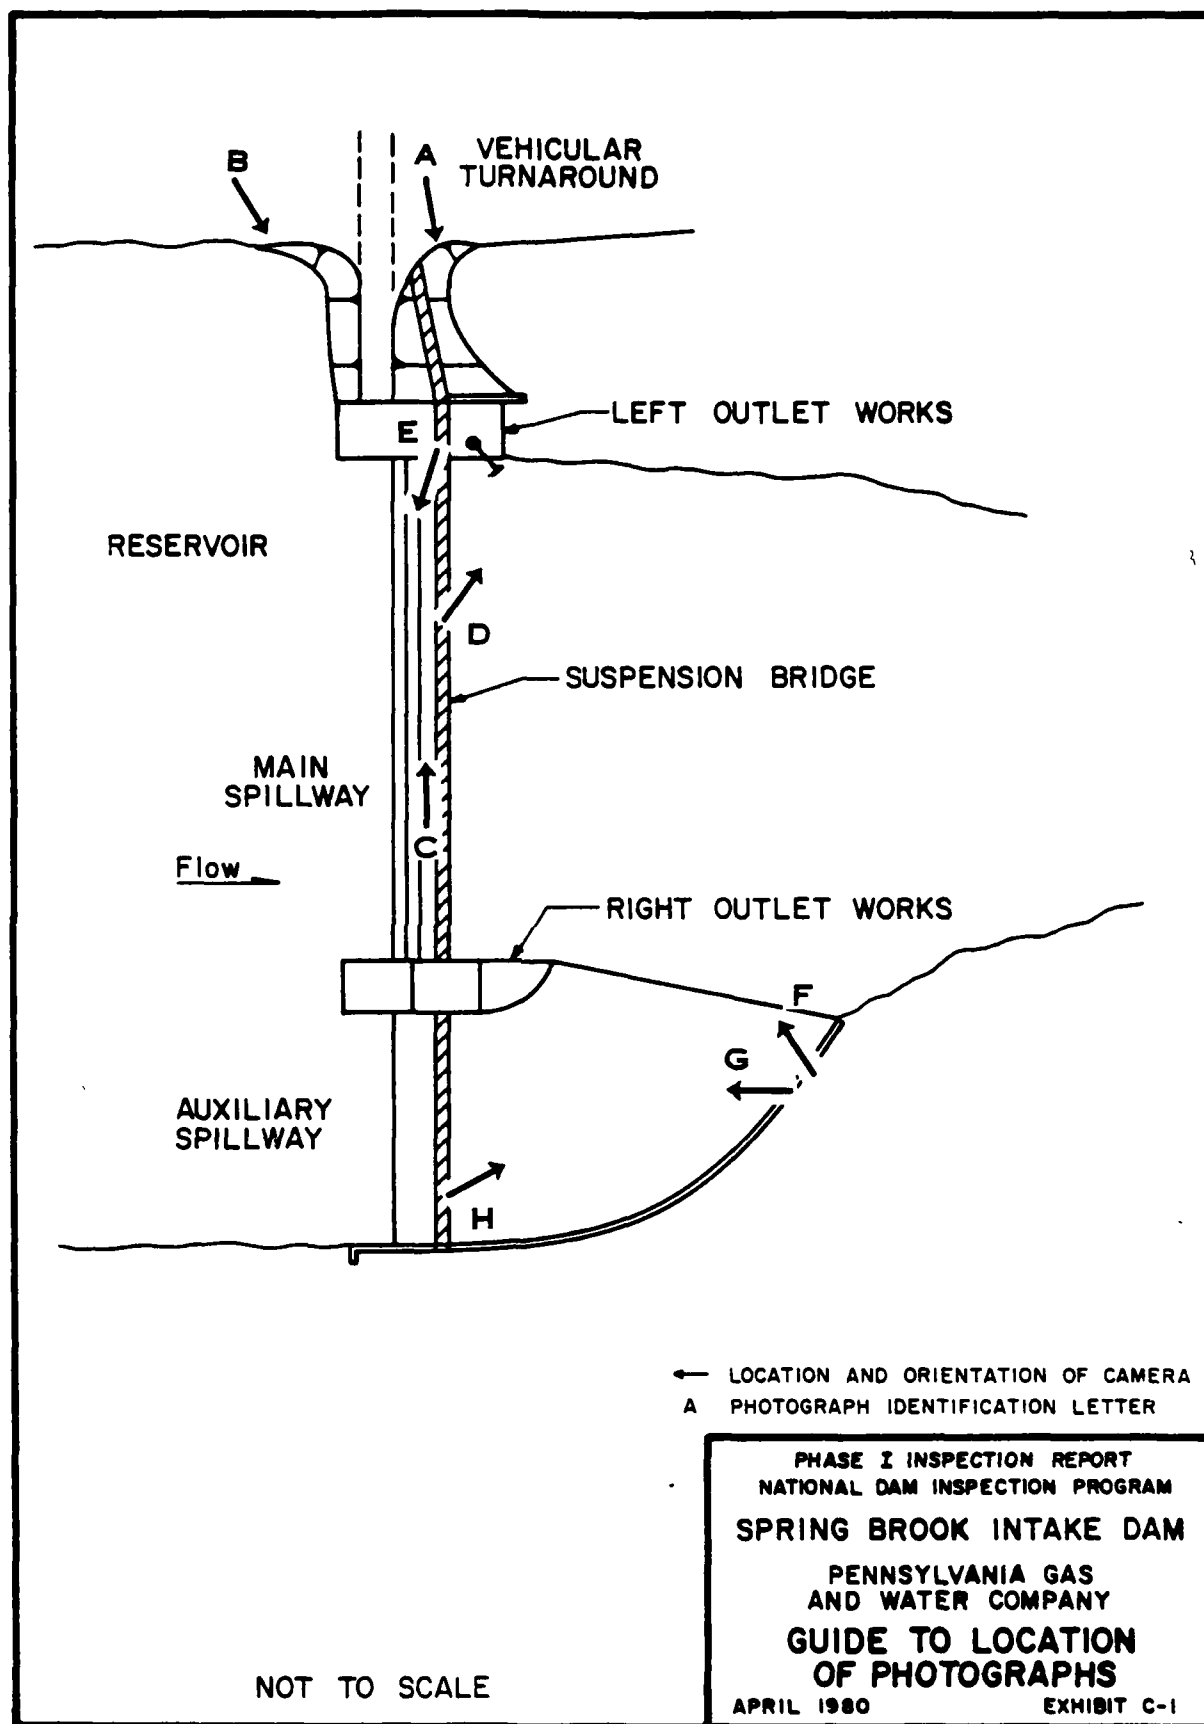
H. Auxiliary Spillway Apron

E, and F). Some minor deterioration of some mortar was evident. The auxiliary spillway and auxiliary spillway apron are also in good condition, with the mortar in approximately the same condition as the main spillway (Photographs G and H). Probing with a rod indicated that a hole about 8 feet deep exists at one location immediately downstream of the downstream end of the auxiliary spillway apron. Fairly large brush stumps were observed at the right abutment of the dam.
